PCI-SIG ENGINEERING CHANGE NOTICE

TITLE:	Surprise Down Error & Link Up Additions
DATE:	4 Feb 2004 (updated 10 June 2004)
AFFECTED DOCUMENT:	PCI Express Base Specification Revision 1.0a
SPONSOR:	David Harriman, Intel Corporation

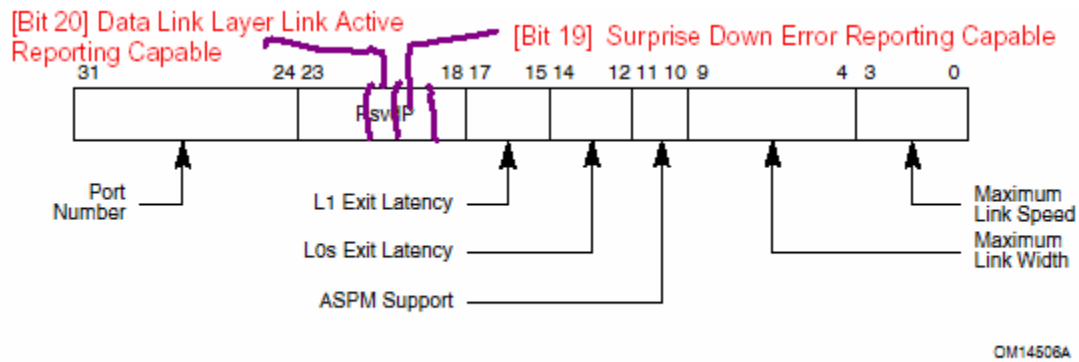
Figure 7-16: Link Capabilities Register

Bit Location	Register Description	Attributes
...		
17:15	...	
<u>19</u>	<u>Surprise Down Error Reporting Capable – For a Downstream Port, this bit must be set to 1b if the component supports the optional capability of detecting and reporting a Surprise Down error condition.</u> <u>For Upstream Ports and components that do not support this optional capability, this bit must be hardwired to 0b.</u>	<u>RO</u>

Bit Location	Register Description	Attributes
<u>20</u>	<p><u>Data Link Layer Link Active Reporting Capable</u> – For a Downstream Port, this bit must be set to 1b if the component supports the optional capability of reporting the DL_Active state of the Data Link Control and Management State Machine.</p> <p>For Upstream Ports and components that do not support this optional capability, this bit must be hardwired to 0b.</p>	<u>RO</u>
31:24	...

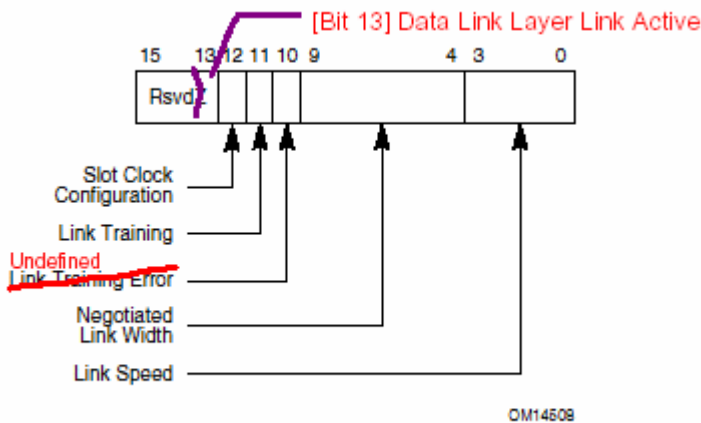
Figure 7-18: Link Status Register

Bit Location	Register Description	Attributes
...		
<u>13</u>	<p><u>Data Link Layer Link Active (Optional)</u> – Set to 1b when the Data Link Control and Management State Machine is in the DL_Active state, 0b otherwise.</p> <p>If this optional status reporting capability is not implemented, this bit must be hardwired to 0b.</p>	<u>RO</u>

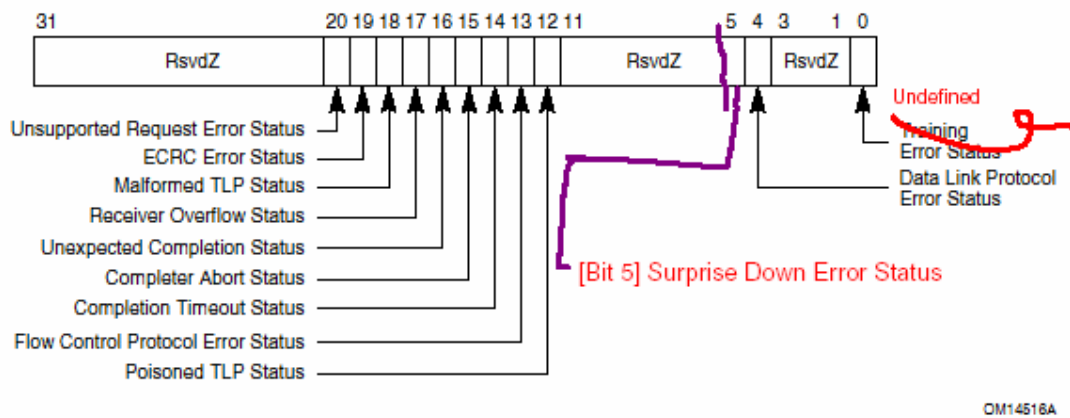
Figure 7-28: Uncorrectable Error Status Register

Bit Location	Register Description	Attributes	Default Value
...			
<u>5</u>	<u>Surprise Down Error Status (Optional)</u>	<u>RW1CS</u>	<u>0</u>
...

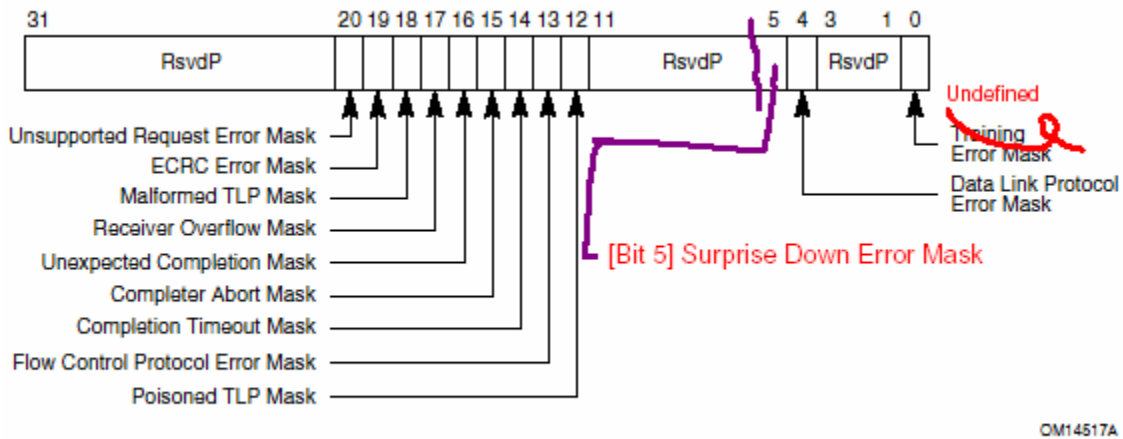
Figure 7-29: Uncorrectable Error Mask Register

Bit Location	Register Description	Attributes	Default Value
...			
<u>5</u>	<u>Surprise Down Error Mask (Optional)</u>	<u>RWS</u>	<u>0</u>
...
